Landmark Giessbach, State 2021

An important maintenance since the Landmark ceremony in 2015 was the **major overhaul of car 1**. The upper part was dismantled and the lower frame brought by helicopter into the workshop of «Garaventa AG, Zweigniederlassung Uetendorf» for a **renewal** of used or worn out parts. All parts were sand blasted and received **new paint**. The accessibility in the workshop allowed an **additional insight**, which was not possible during the landmark brochure preparation. The **wooden superstructure** of the car was renewed in the historic open style and it got another paint, **which is believed by the preservation authority to be the initial one**. Indeed these open cars fit best into the measures taken against the Covid virus since 2020

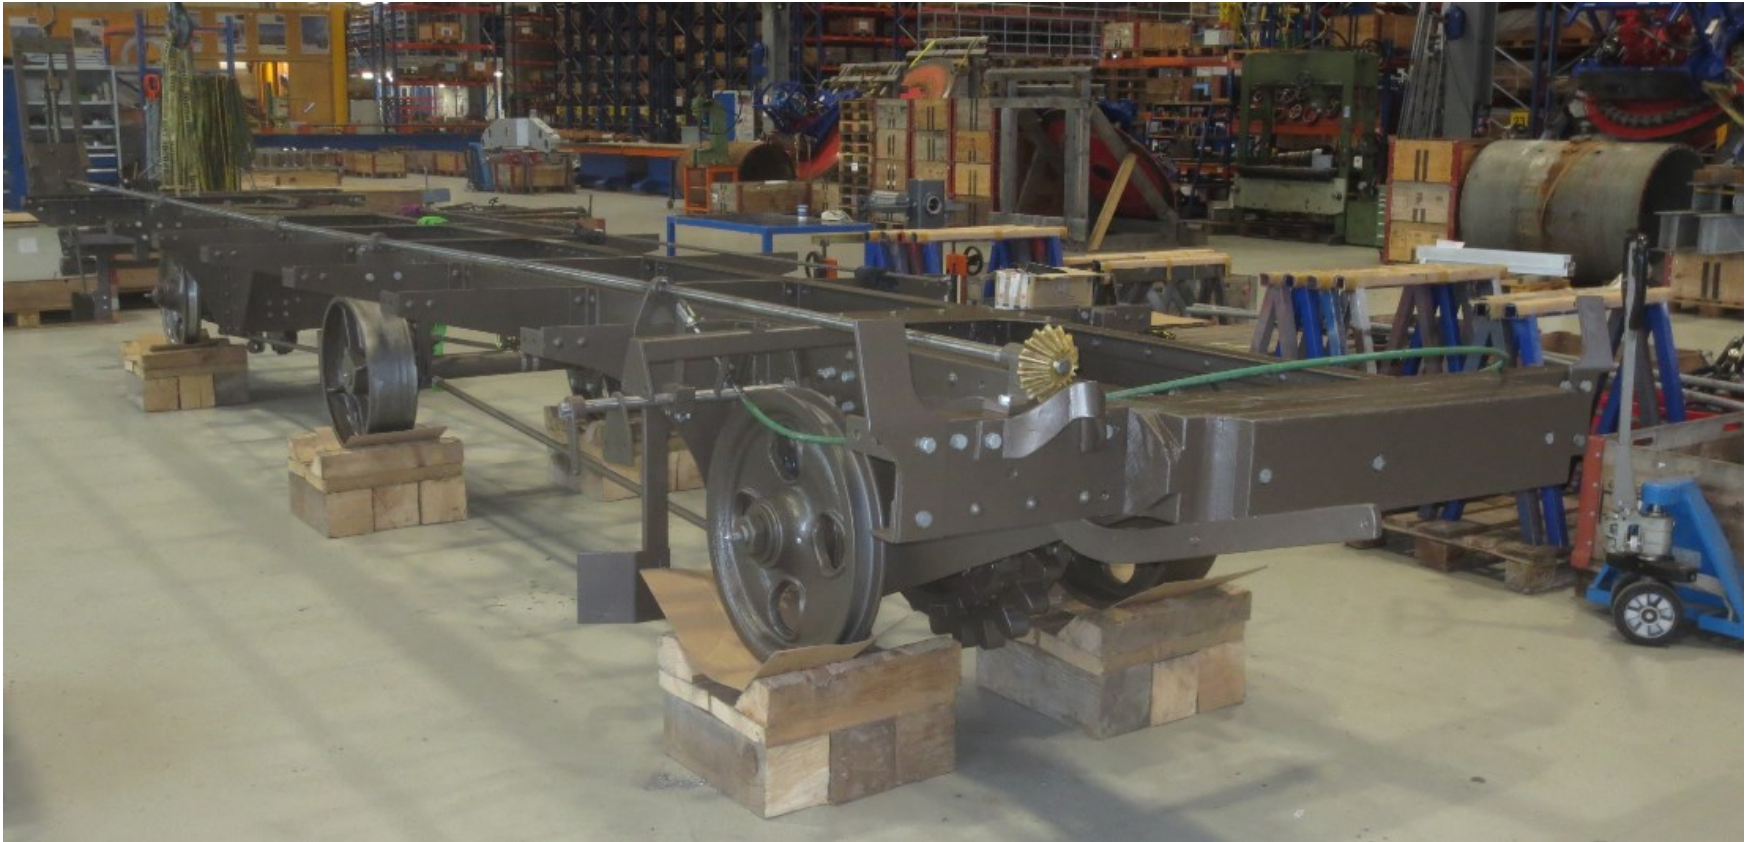
Base Frame in the workshop after refurbishment

View from the downside end: This is the same **base frame version as modified in 1912**, where the water tanks were removed (by Bell, Kriens) and the lower two axis mounted initially in a bogie were replaced by a stiff arrangement with the **middle axis having no wheel flanges**. All steel parts were sand blasted and have a new paint. Photo HW, 2020-02-25

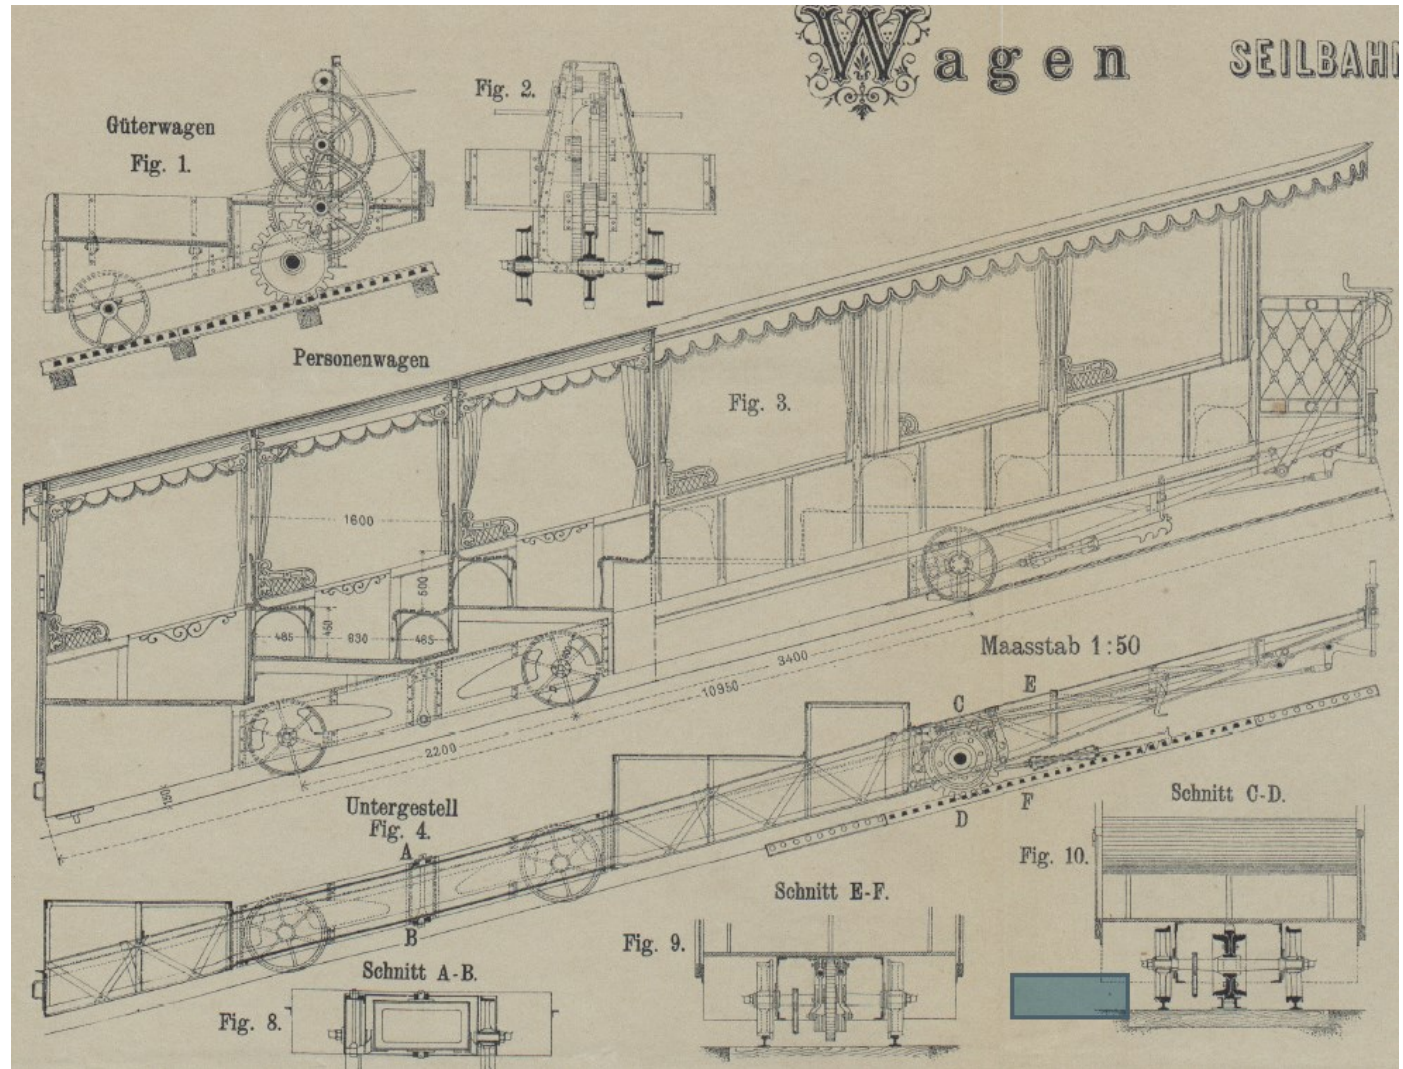
Initial Base Frame Drawing from Abt's publication

This is part of a drawing in Abt's publication from 1879. The "Güterwagen" upside left was hand operated and used during construction of the track. It does not exist anymore. The car with water tanks had three axis with the lower two assembled in a bogie. The break system acting to the cograil is magnified and commented in a slide below.

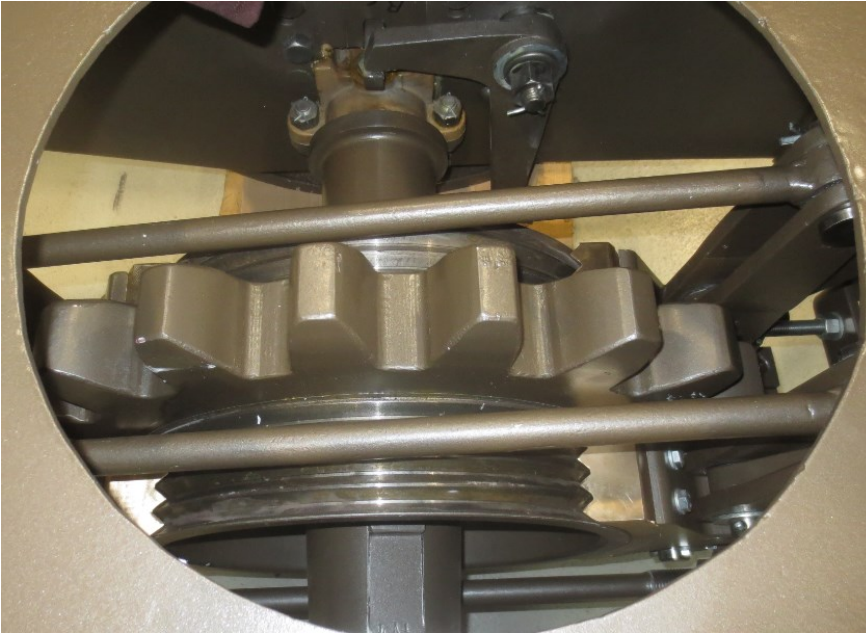
Base Frame upper side, break mechanism

This is the current **parking brake** with the **activation crank**. It acts to the teeth wheel on the mountain side engaged in the Riggerbach-type cog rail. The **key slotted design** corresponds to Abt's drawing shown below. At Abt's time this break was used to control the speed by hand. It had an additional automatic release by slack cable. Abt reports from his experience in operation that half a turn of the crank in one car stops both cars. Since 1912 (?) this (upper) device is only used to block the car for service work while there is a second similar emergency brake added at the lower axis of the car. Photos HW, 2020-02-25

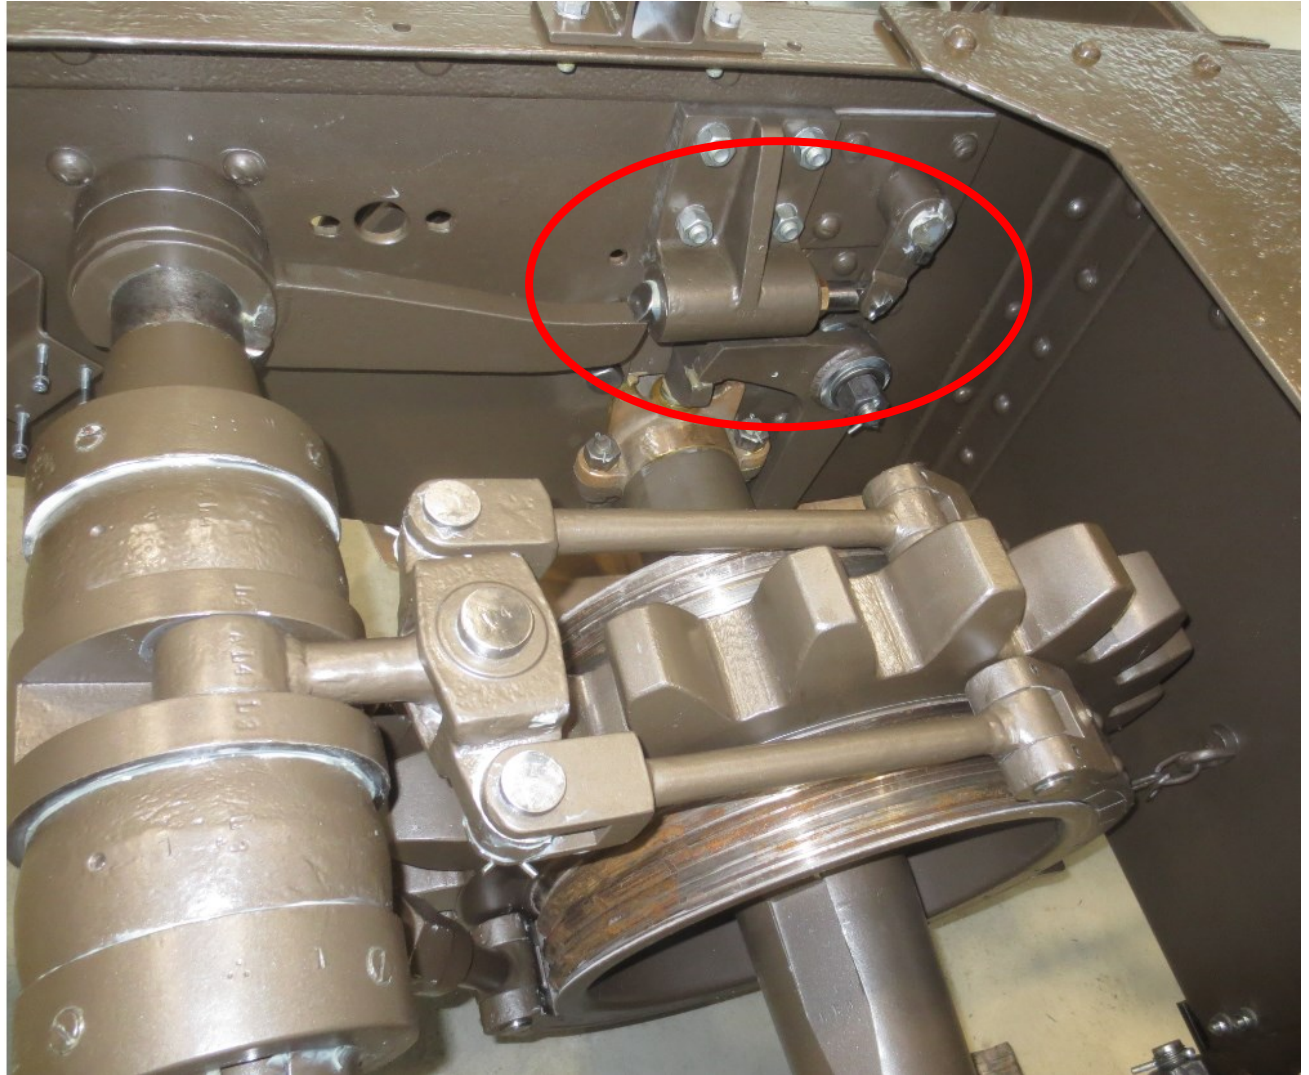
Emergency brake (lower side of the car)

This is the actual band brake at the lower axis of the car. It is weight loaded and it acts via teeth wheel to the Riggensbach –type cog rail.

The emergency release mechanism is marked with red. It is activated automatically either in case of slack cable or of over-speed.

In Abt's drawing of 1879 the brake drum was slotted like the current upper side one. This brake was added in 1912 or later. This drum is smooth as visible here.

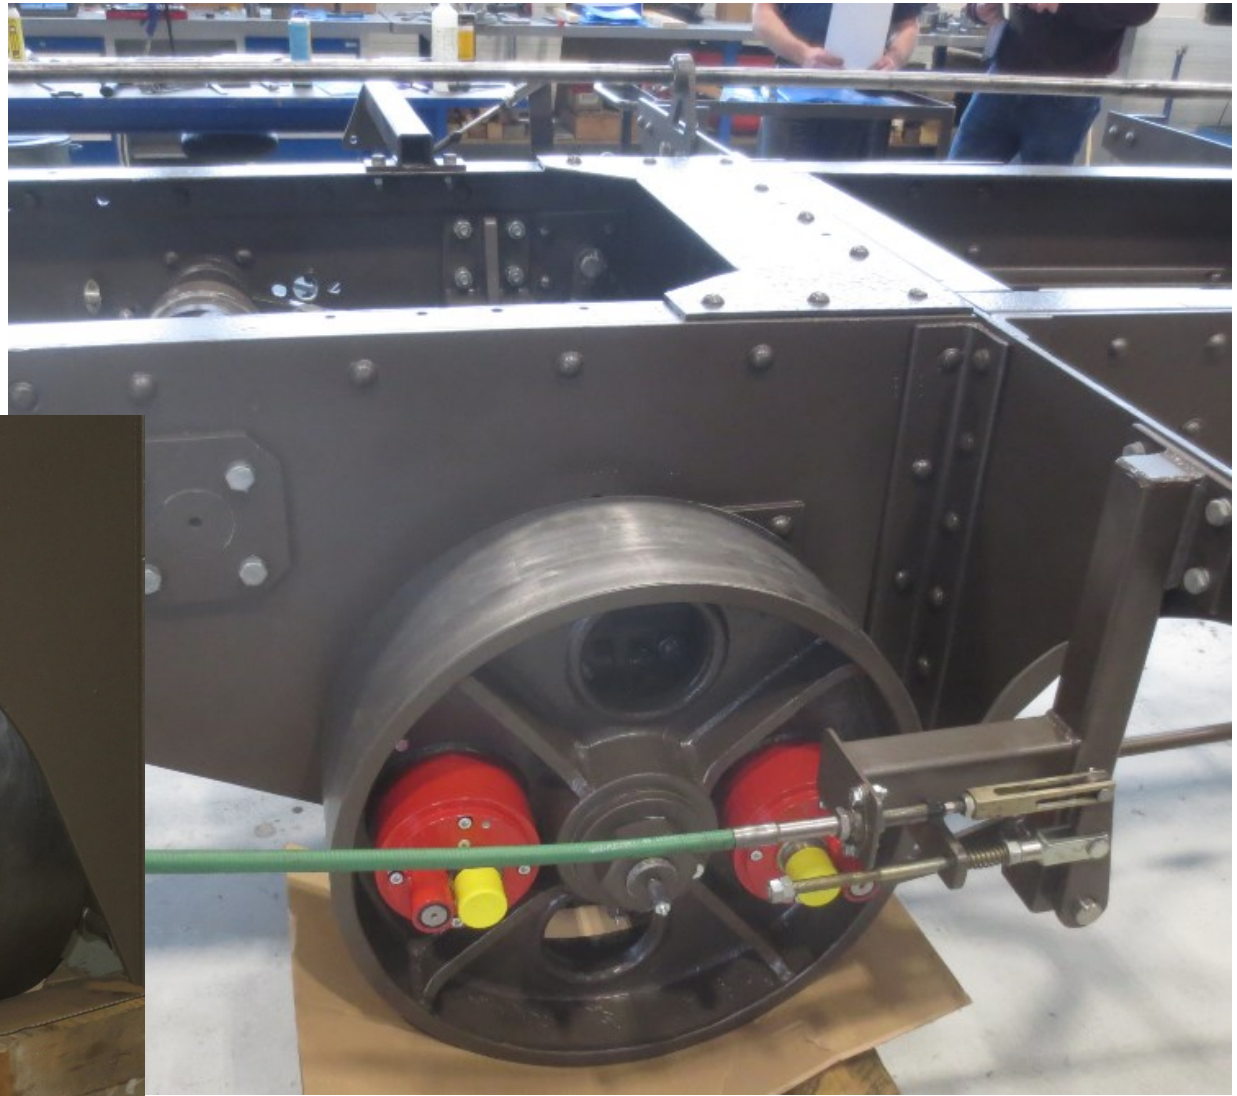
Overspeed detector for emergency brake release

This device was introduced before the actual refurbishment. It is here in the refurbished state.
Photo HW, 2020-02-25

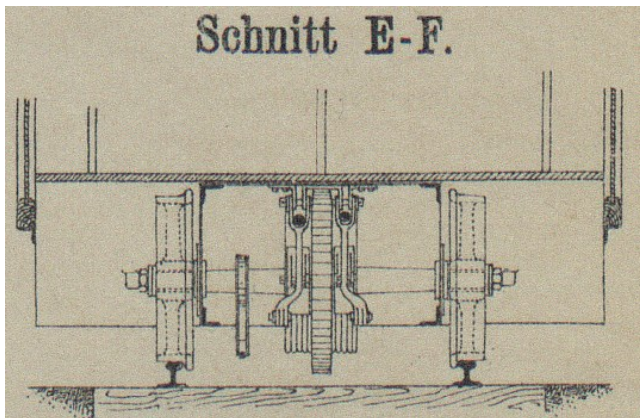
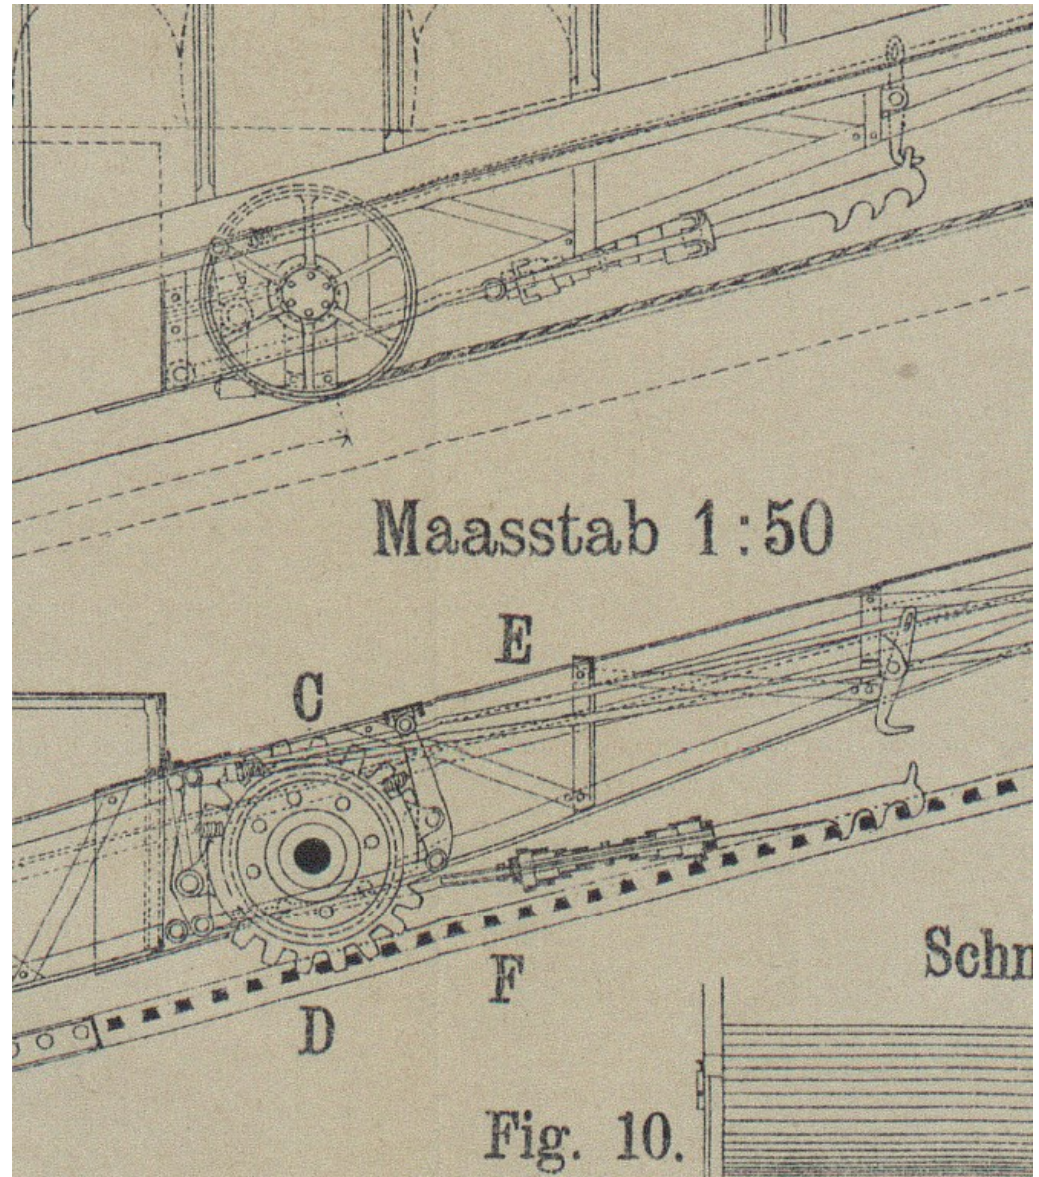
Magnification of Abt's break systems

According to the drawing there was only one break teeth wheel as shown here. It was used for speed control in operation by the driver. Nominal speed was **1 m/s**. Abt talks on the case of a cable rupture. He mentions the automatic release of this break in case of slack cable. He mentions additionally a second **three-hook brake** engaging into the cog rail with automatic release in case of a cable rupture. He considered a spring within the connection to the car in order to reduce the dynamic load. However in another part of the paper he mentions, that this hook device was **not installed**. Thus, it remains unclear whether this was ever installed or not.

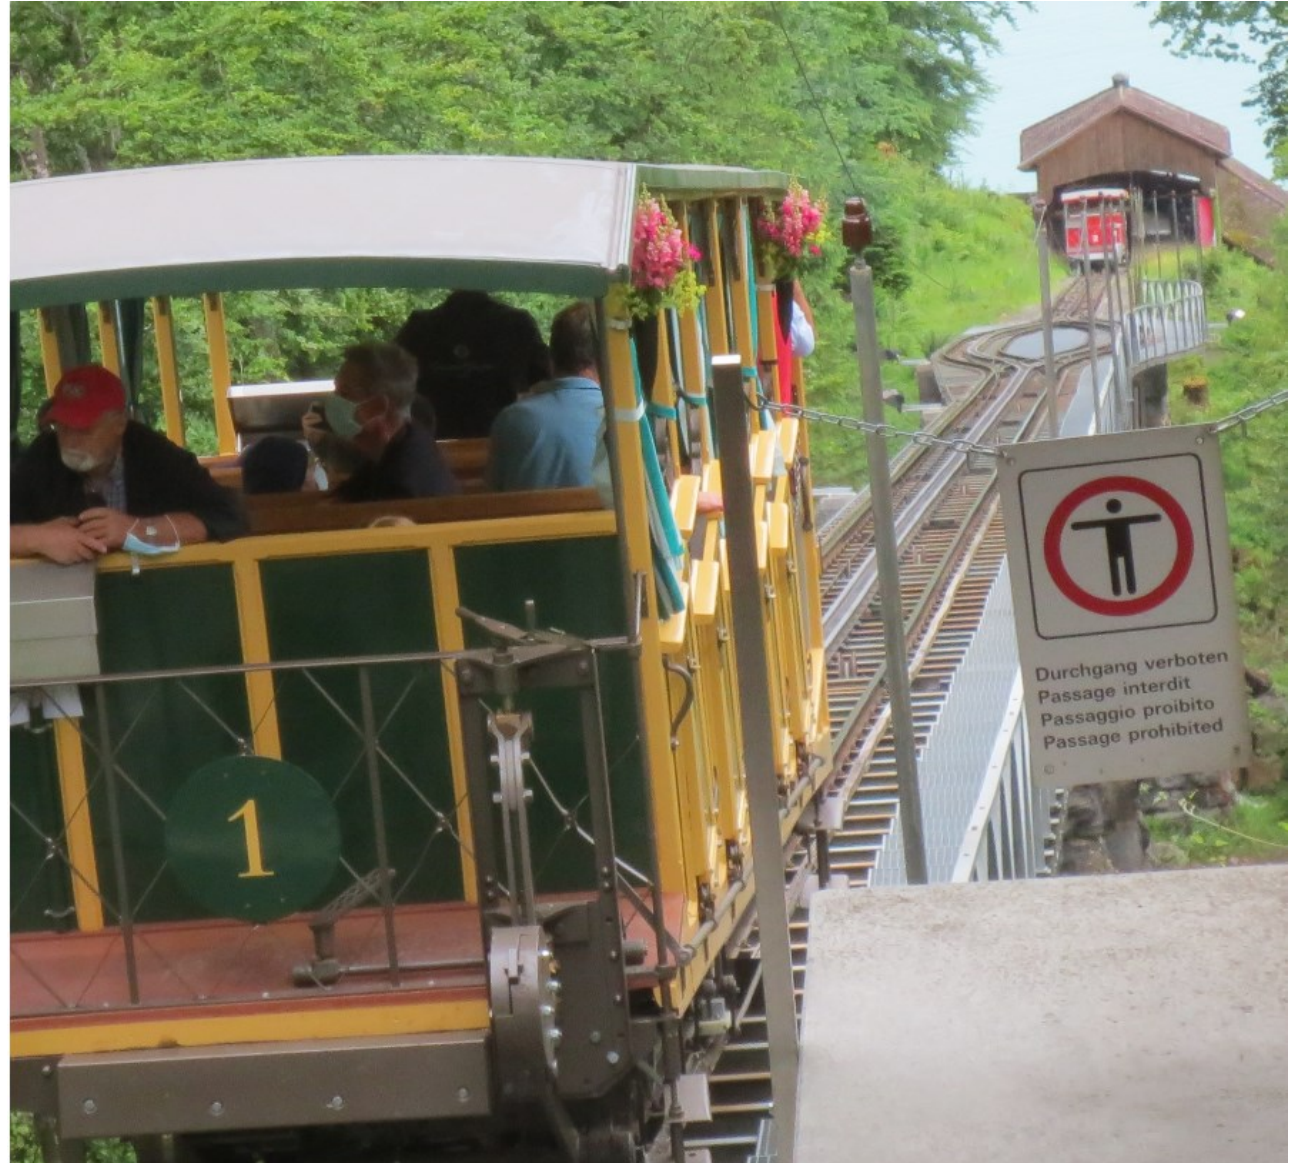
Appearance of Car 1 with the new paint

In Switzerland the mountain railways are typically red with a few exceptions especially to distinguish two cars. **Car 1** (turning right in this picture) is the renewed one with a painting that is believed to be the initial one. The car 2 in the back is still red. Its renewal is presumably planned for the winter break 2023.
