Landmark Giessbach, State 2021

An important maintenance since the Landmark ceremony in 2015 was the **major overhaul of car 1**. The upper part was dismantled and the lower frame brought by helicopter into the workshop of «Garaventa AG, Zweigniederlassung Uetendorf» for a **renewal** of used or worn out parts. All parts were sand blasted and received **new paint**. The accessibility in the workshop allowed an **additional insight**, which was not possible during the landmark brochure preparation. The **wooden superstructure** of the car was renewed in the historic open style and it got another paint, **which is believed by the preservation authority to be the initial one**. Indeed these open cars fit best into the measures taken against the Covid virus since 2020

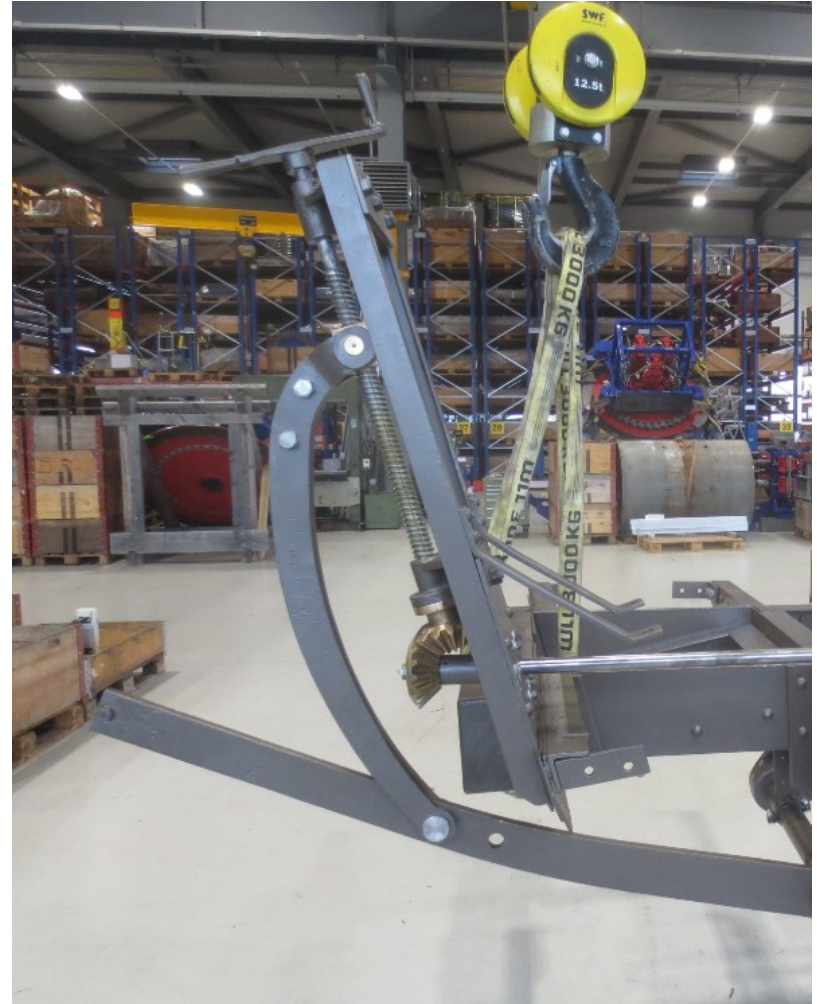
Base Frame upper side, break mechanism

This is the current **parking brake** with the **activation crank**. It acts to the teeth wheel on the mountain side engaged in the Riggerbach-type cog rail. The **key slotted design** corresponds to Abt's drawing shown below. At Abt's time this break was used to control the speed by hand. It had an additional automatic release by slack cable. Abt reports from his experience in operation that half a turn of the crank in one car stops both cars. Since 1912 (?) this (upper) device is only used to block the car for service work while there is a second similar emergency brake added at the lower axis of the car. Photos HW, 2020-02-25
